ANALYSIS OF A SHALLOW SLOPE FAILURE IN WEATHERED ROCK

1. Background

In May 2016, we flew a UAV (unmanned aerial vehicle, or drone) over part of Belmont Quarry, Lower Hutt, to record detailed photographs of localised bench failures. This was to help us develop a work flow that would start with the drone photography and conclude with back analysis of the slope failure using our 3D slope analysis program, TSLOPE.

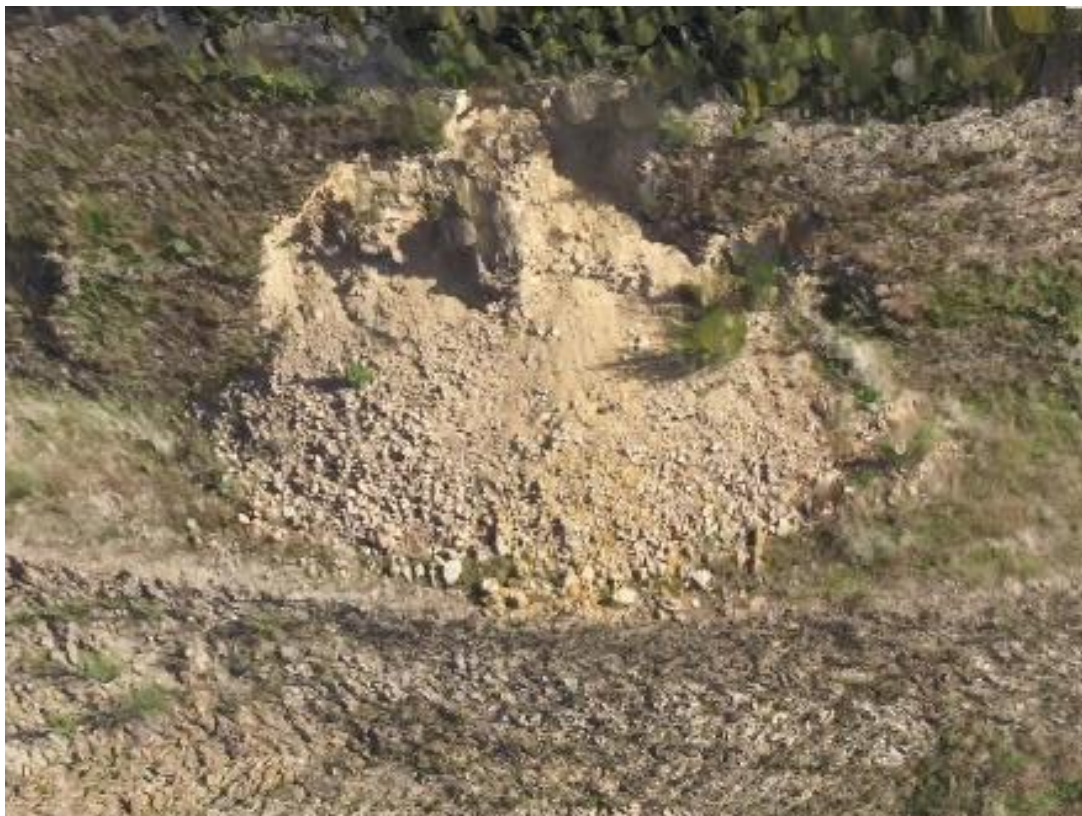
A DJI Phantom 3 Advanced UAV was flown over Belmont Quarry. A subset (34) of the large number of images were processed using Pix4D software to generate the ortho-mosaic shown in Figure 1. There was good overlap of images over the area, with more than 5 images overlapping for each pixel location.

Figure 1 Orthophoto mosaic showing area of shallow slope failure.

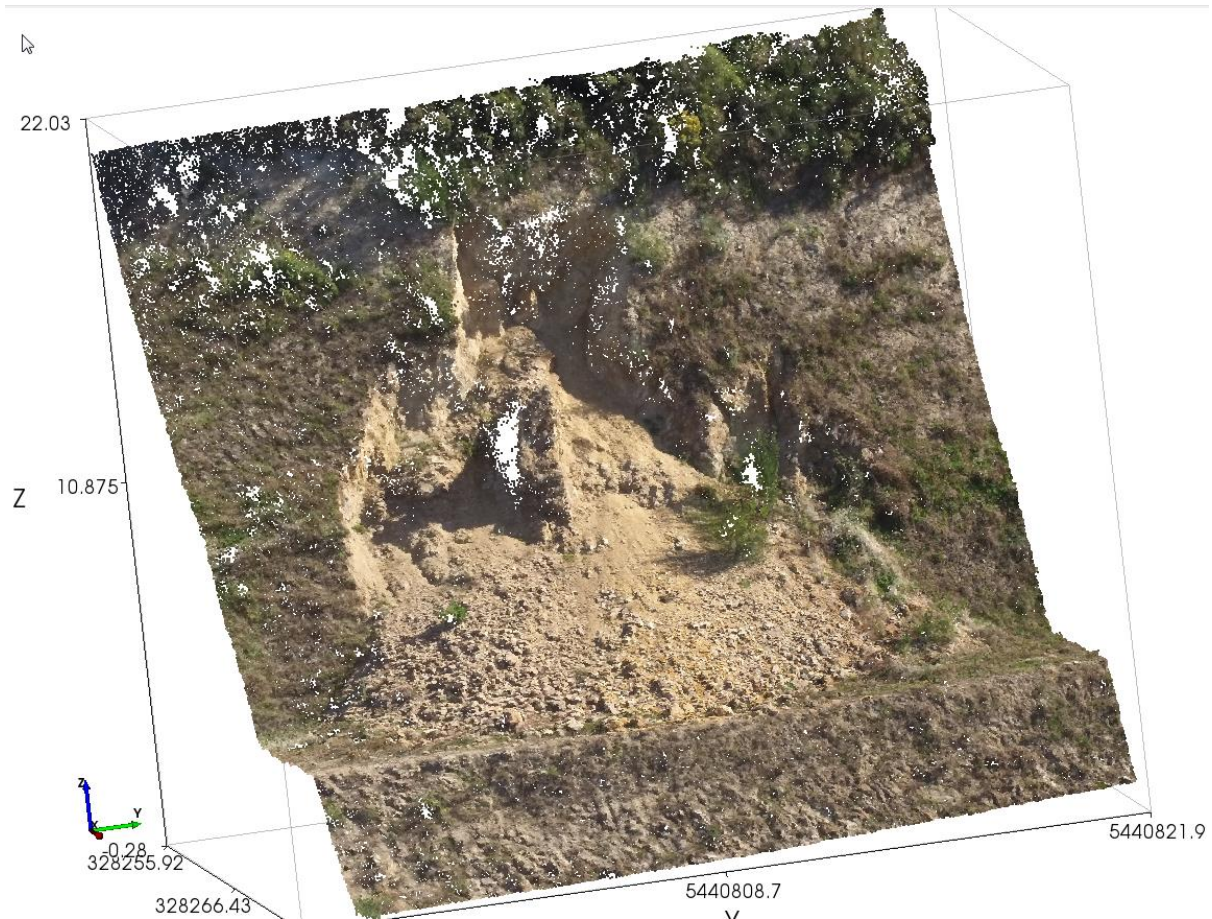
A cloud of points with values for x, y, z as well as RGB (red, green, blue values for each point) was also generated by Pix4D. The cloud of points data (1,033,537 points) were loaded into TSLOPE to assist with visualisation of the slope, as shown in Figure 2. Because of the RGB attributes of each point, a photo-like image is created.

Figure 2. Cloud of points as displayed in TSLOPE.

The shallow slope failure has occurred on a bench slope on the upper levels of the quarry. The quarry produces aggregate for the local construction industry from a highly indurated quartzofeldspathic sandstone, with interbedded siltstone, known locally as “greywacke”. The rock in the upper levels of the quarry is variably weathered, hence the brown colour of the rock as shown in Figure 2.

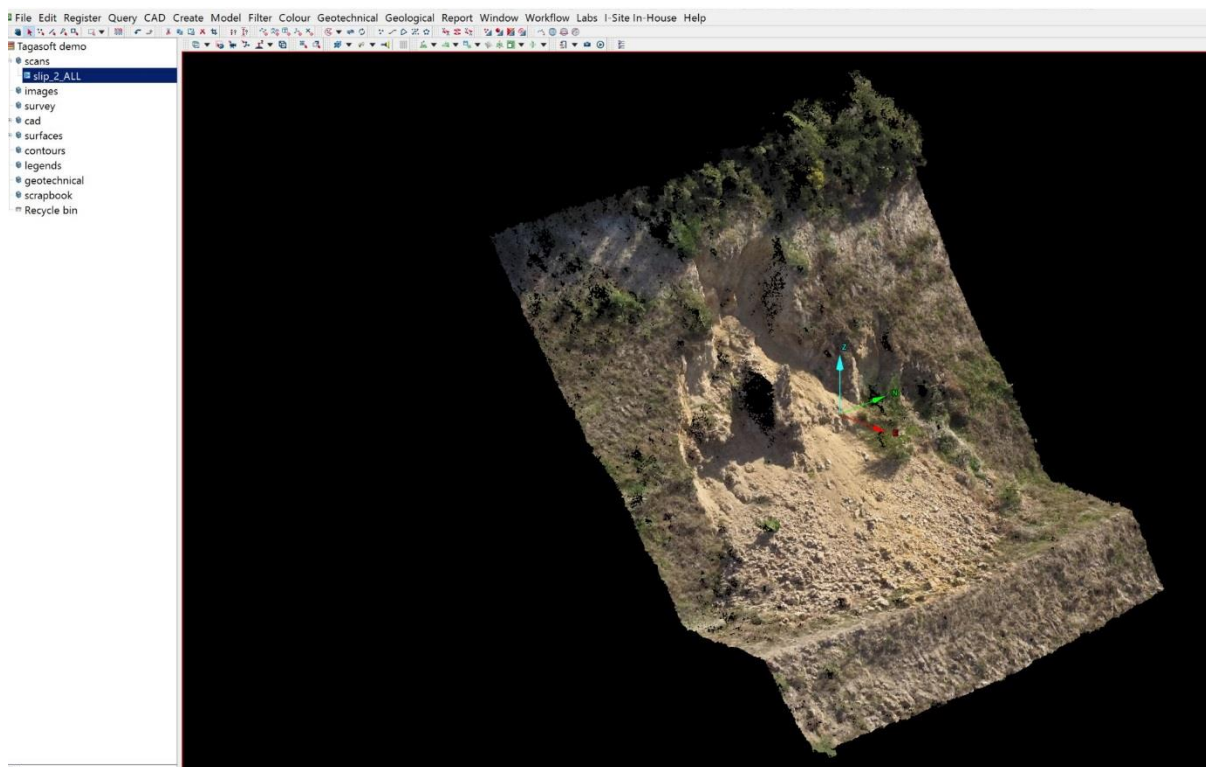
The raw UAV data were loaded into I-Site and viewed in 3D (Figure 3).

Figure 3. Raw cloud of points viewed in I-Sight.

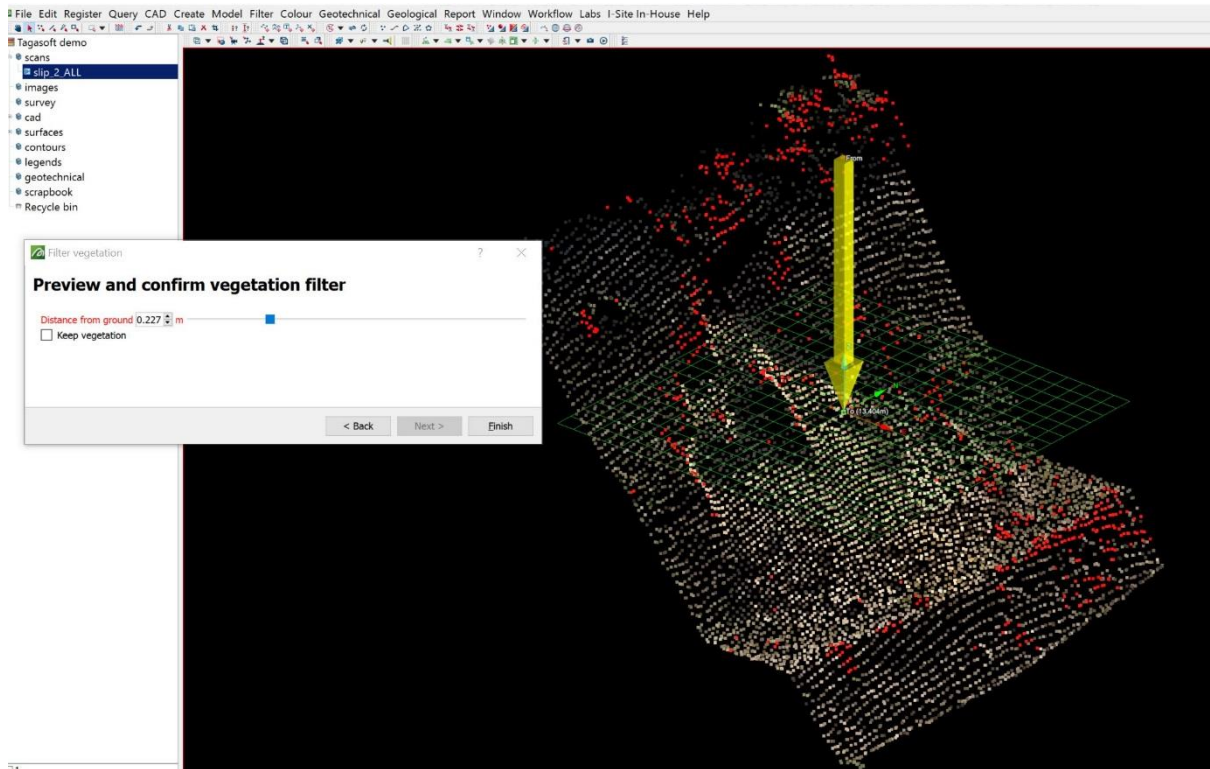
I-Sight can distinguish points that have been located on vegetation, using colour as a criteria. The software is then able to clear selected points, as shown in Figure 4, from the scene.

Figure 4. Vegetation filter applied to cloud of points.

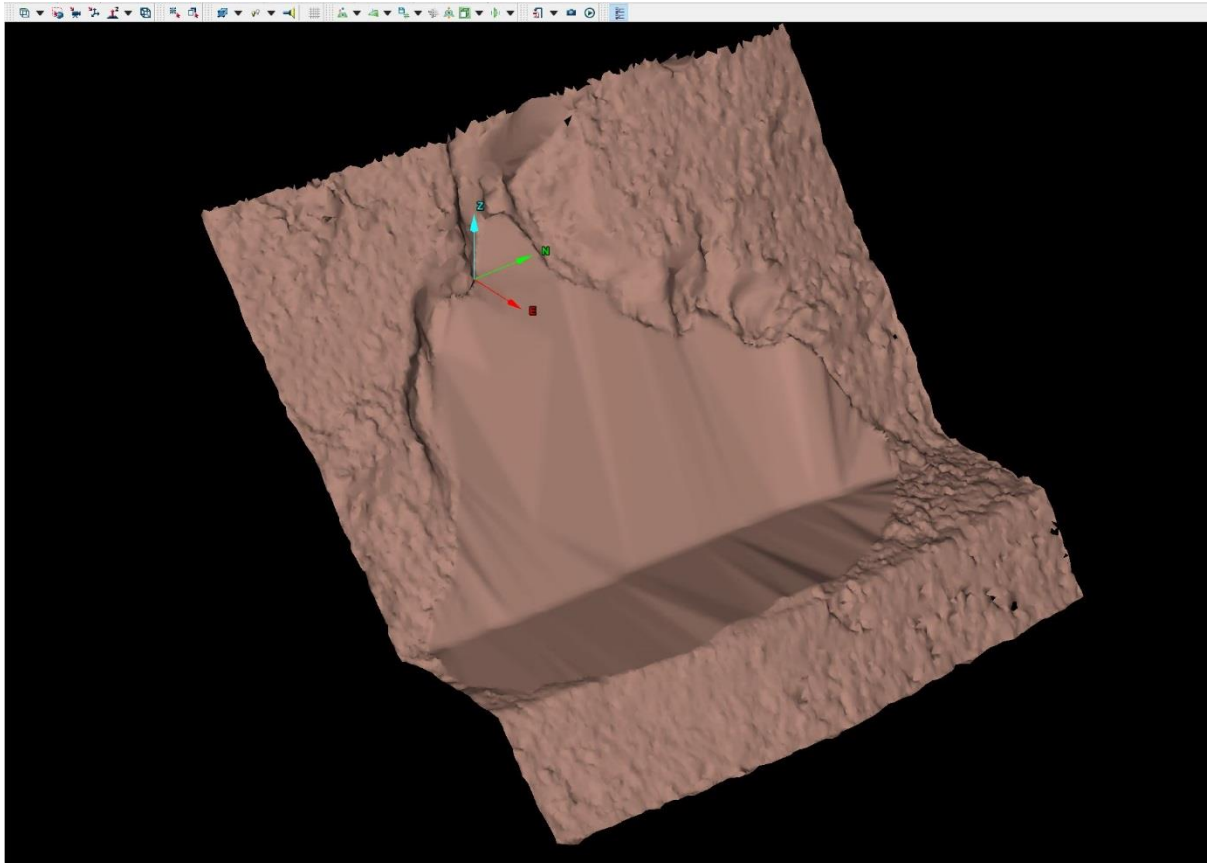
I-Sight was then used to construct the two surfaces we need to import to TSLOPE. The first is the pre-failure topography, and this was constructed by removing the points involved with the slope failure, and constructing a continuous surface across the remaining points (Figure 5).

Figure 5. Re-constructed ground surface prior to slope failure.

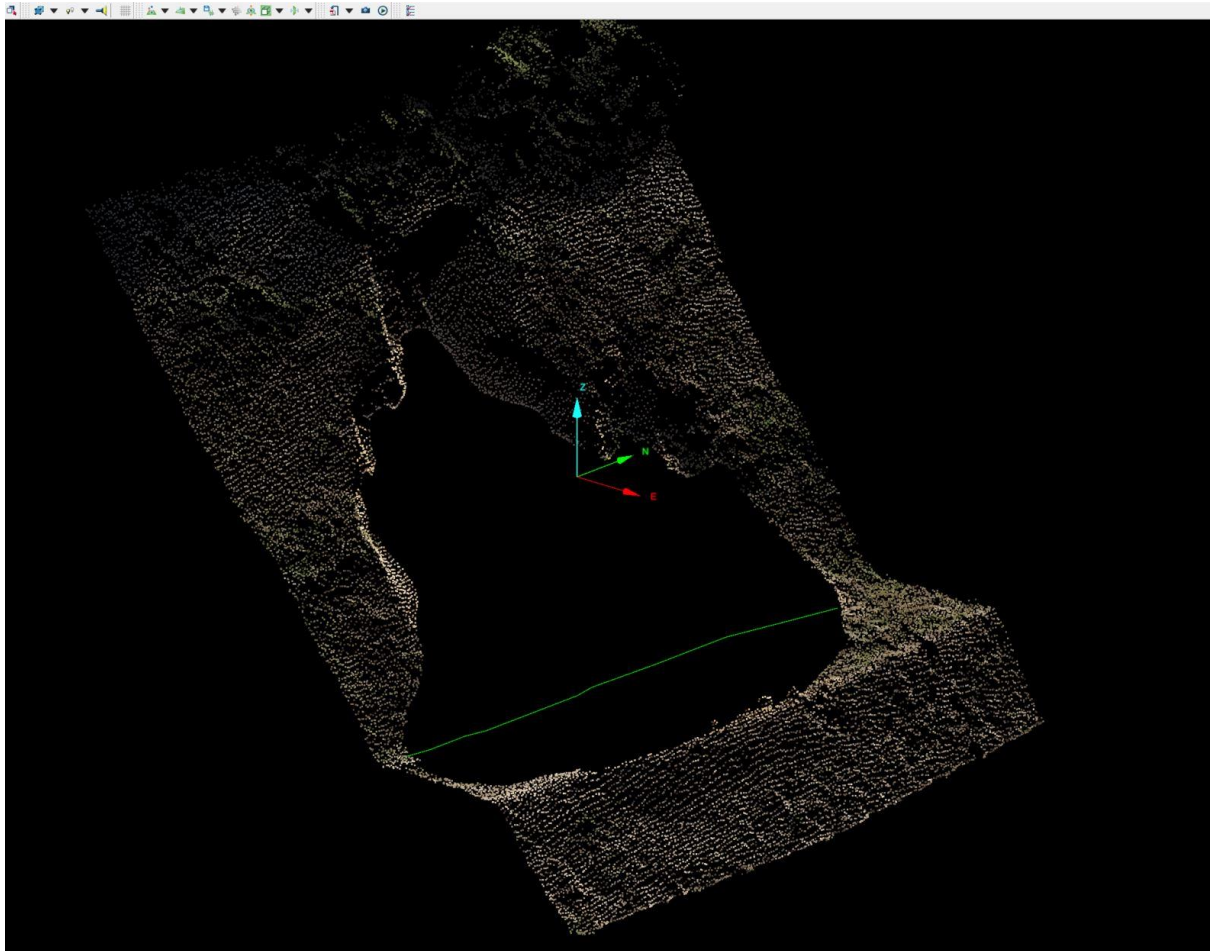
Further manipulation of the cloud of points allowed modelling of the failure surface, with the assumption that the base of the shear surface intersected the toe of the slope. This is shown in Figure 6.

Figure 6. Modified cloud of points in preparation for modelling of slide surface.

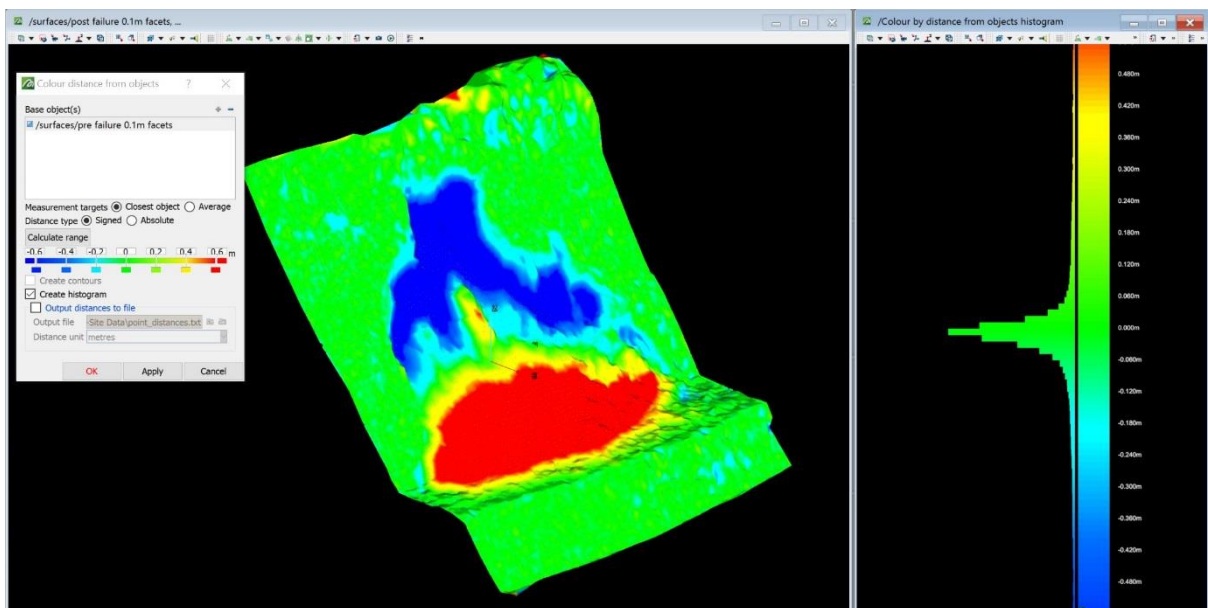
Figure 7. Comparison of pre slide and after slide topography.

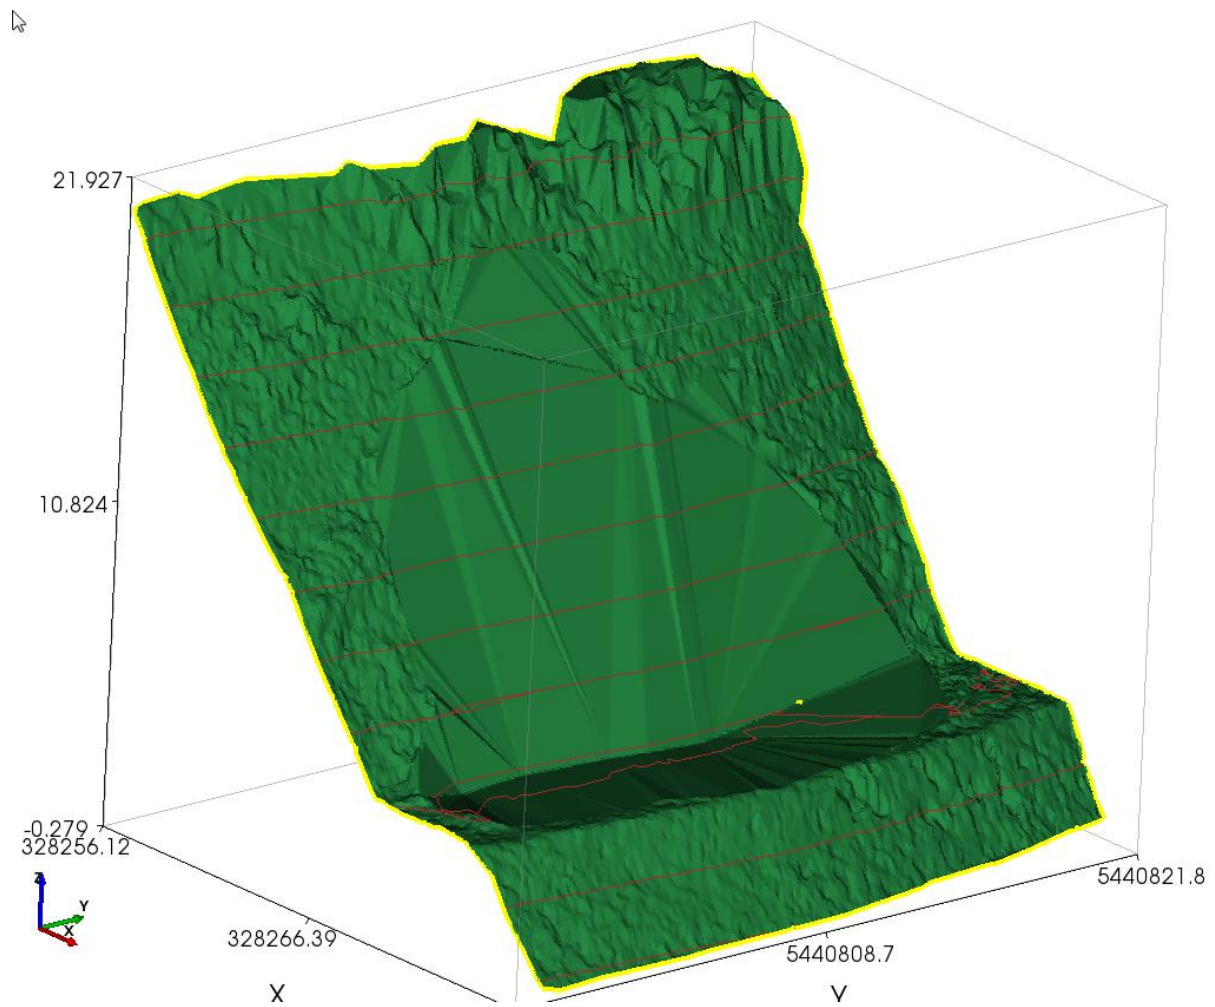
The original topographic surface .obj file was loaded into TSLOPE as the Top surface, and is shown in Figure 8.

Figure 8. TSLOPE model Top surface.

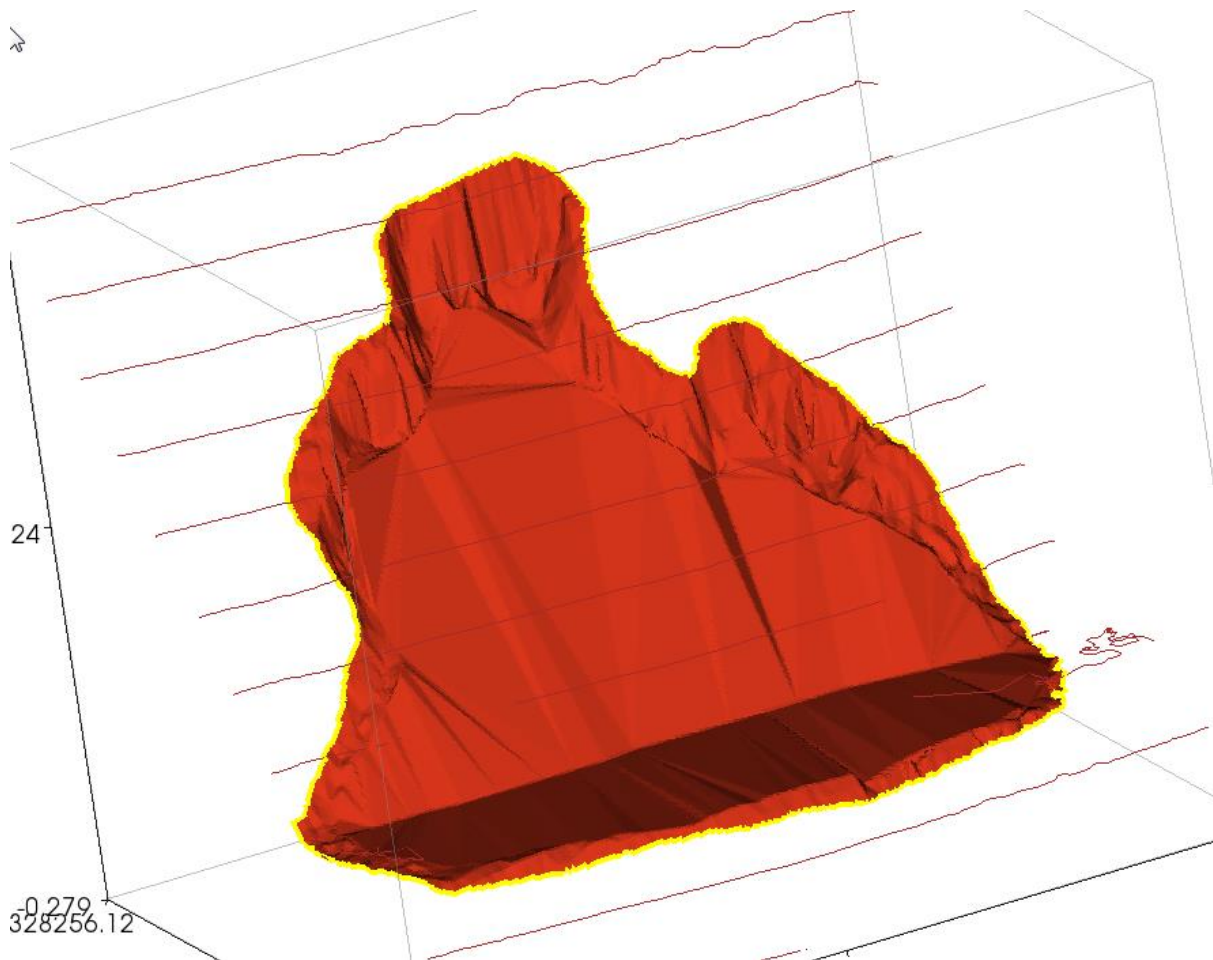
The shear failure surface was then loaded into TSLOPE as a Basal surface (Figure 9).

Figure 9. TSLOPE model basal surface.

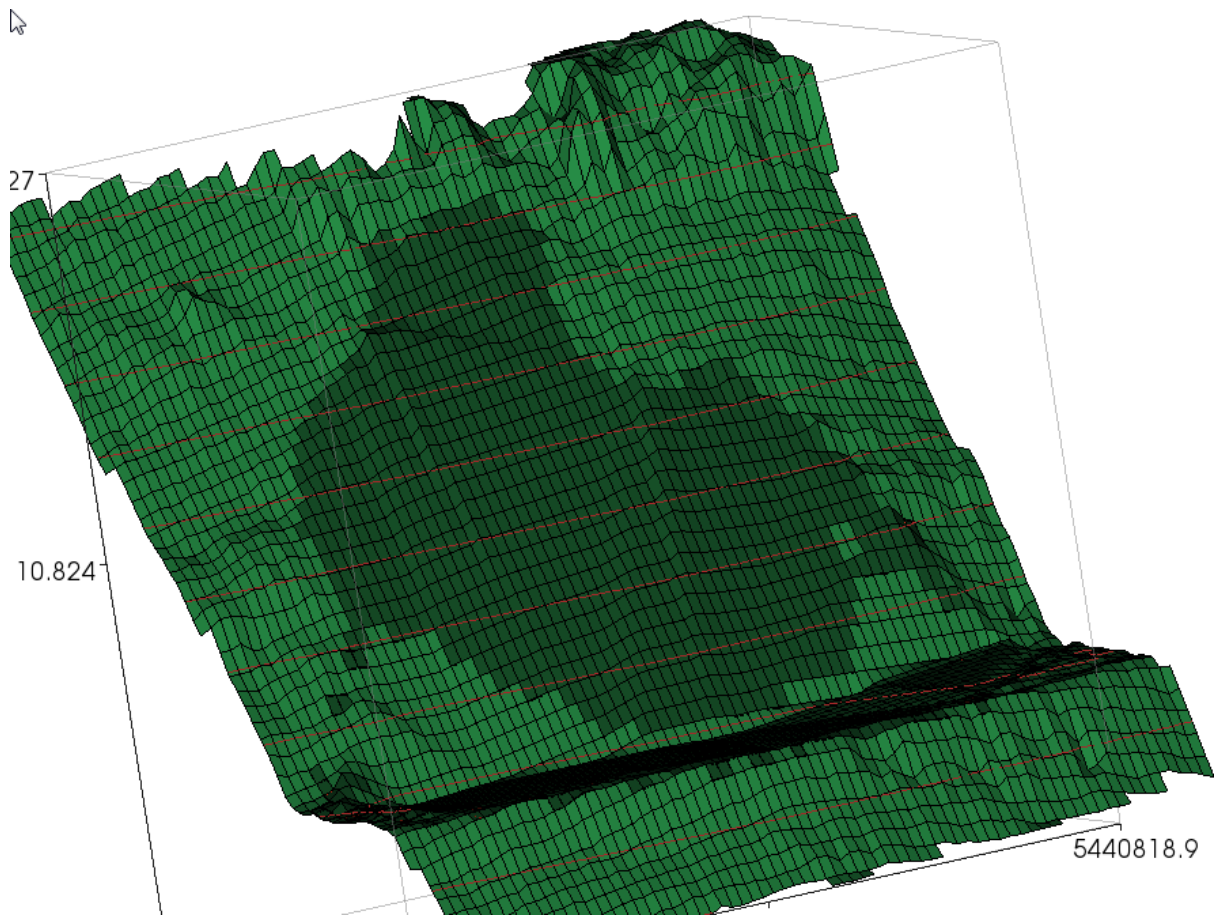
The slope case discretises the model into vertical columns overlying the basal surface. The model was set up with 100 columns across the width of the model, as shown in Figure 10. The darker colour columns are the active columns involved in the slope stability calculations.

Figure 10. Three dimensional slope stability model showing arrangement of vertical columns.

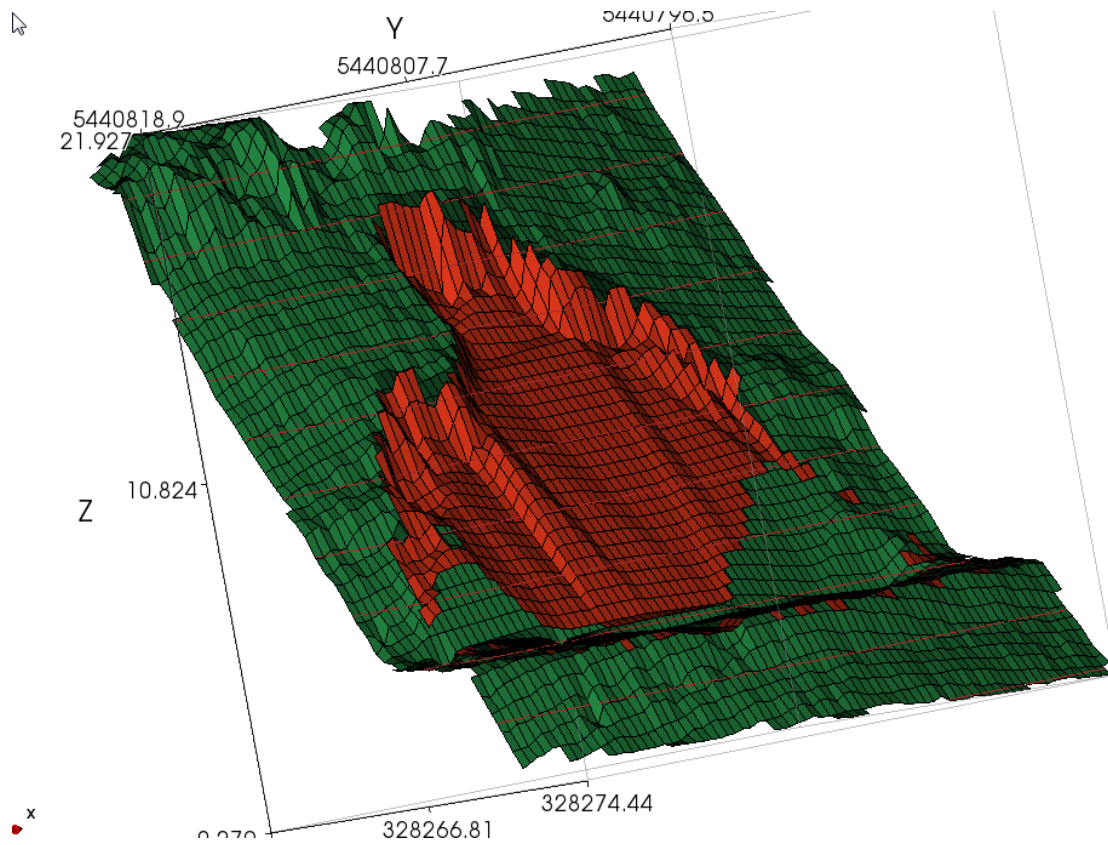
Figure 11. View from behind the slope model, showing the Basal shear surface.

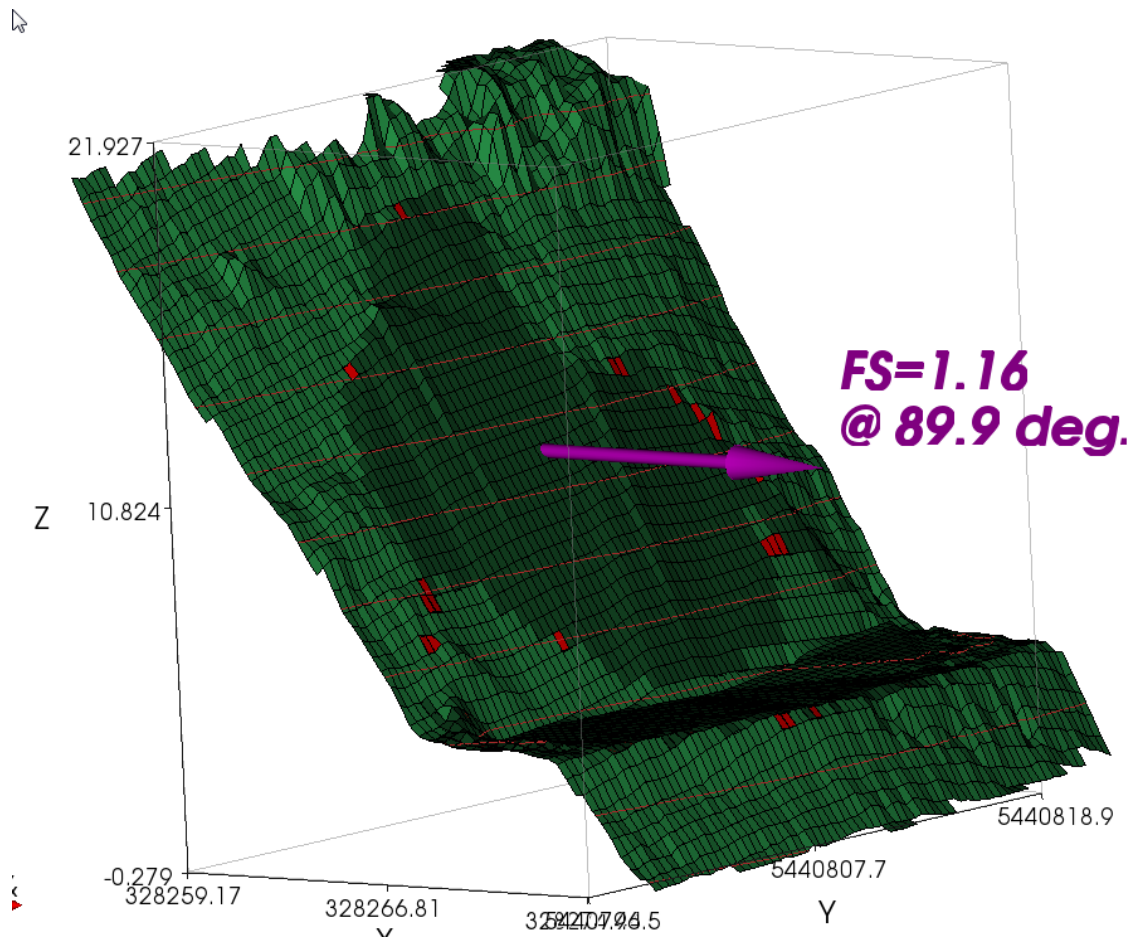
TSLOPE then provided a solution using Spencer's method, with a calculated factor of safety of 1.16 (Figure 12). This suggests that the strengths used in the model are a little higher than would have applied at the time of failure.

Figure 12 Result of 3D analysis using Spencer's method.

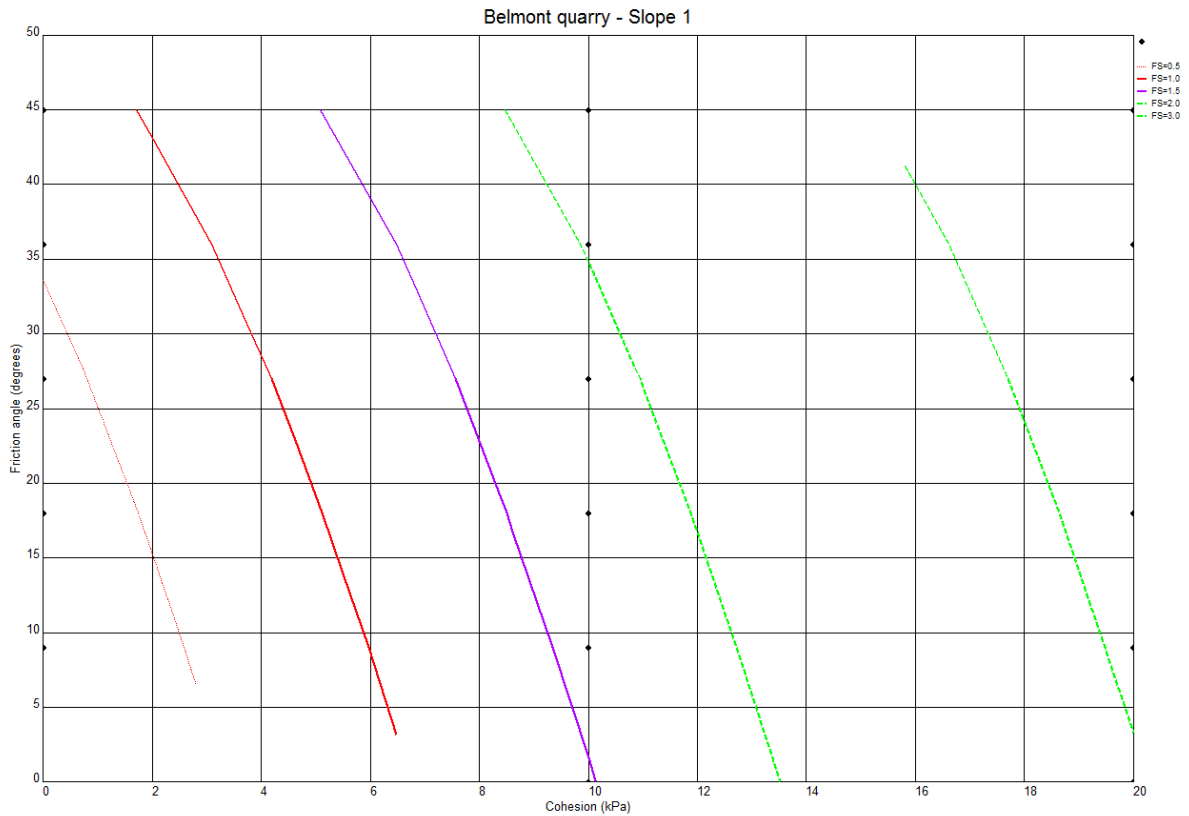
To help understand the range of strengths that would apply at a factor of safety of 1.0, we have carried out a back analysis of the slope failure using different combinations of Mohr Coulomb parameters c and ϕ . A cross plot showing the range of strengths corresponding to different factors of safety is shown in Figure 13.

Figure 13. Cross plot of friction angle (vertical axis) and cohesion with calculated factor of safety. Red line is FS = 1.

To help understand the range of strengths that apply in shallow slope failures such as we have described, it is recommended that other slope failures are systematically studied in this way. By aggregating the cross plots as shown in Figure 13, it will be possible to show the range of strengths that should apply to weathered greywacke at shallow depth below ground surface.
