TSLOPE

THE 1979 ABBOTSFORD LANDSLIDE, DUNEDIN, NEW ZEALAND

An instructive example of how TSLOPE can carry out 2D and 3D stability analyses using a geotechnical model constructed in Leapfrog®.

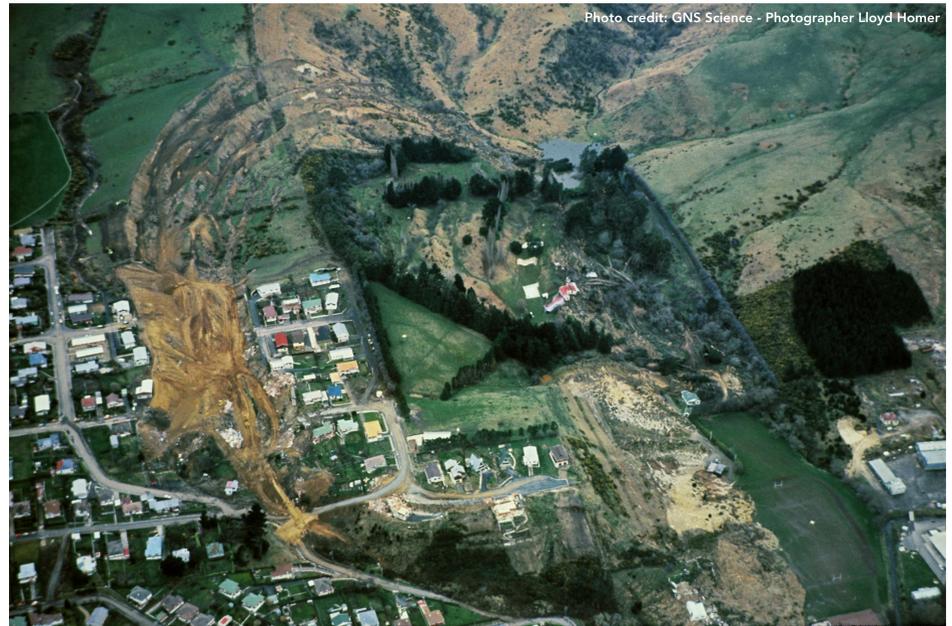
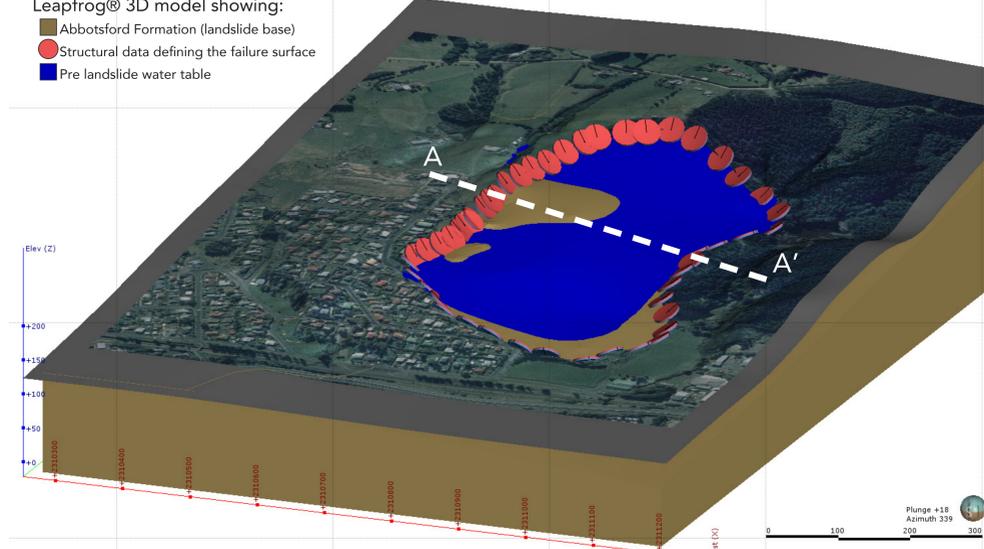
Leapfrog® 3D model showing:

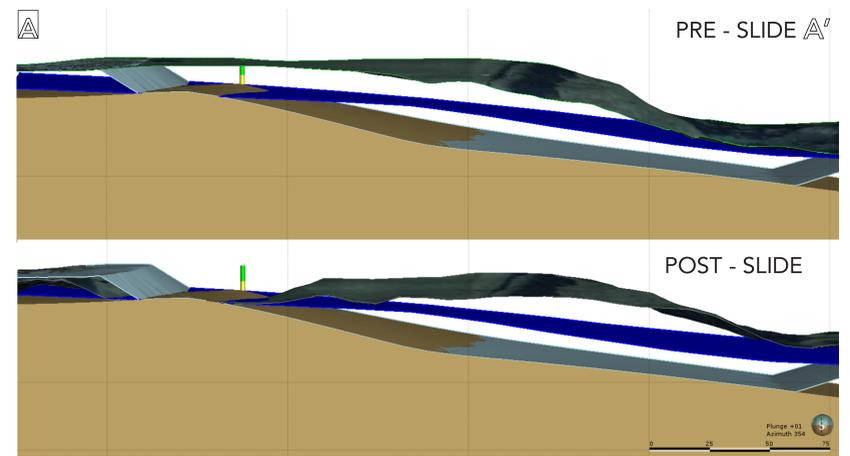
The model within Leapfrog® shown in 3D view, and in sections.

TAGAssoft have worked with Graham Hancox to assemble the data that were used to build a Leapfrog® model of the landslide area. These included geological maps, drill hole logs, topographic maps at different times, groundwater data, and geotechnical laboratory testing data.

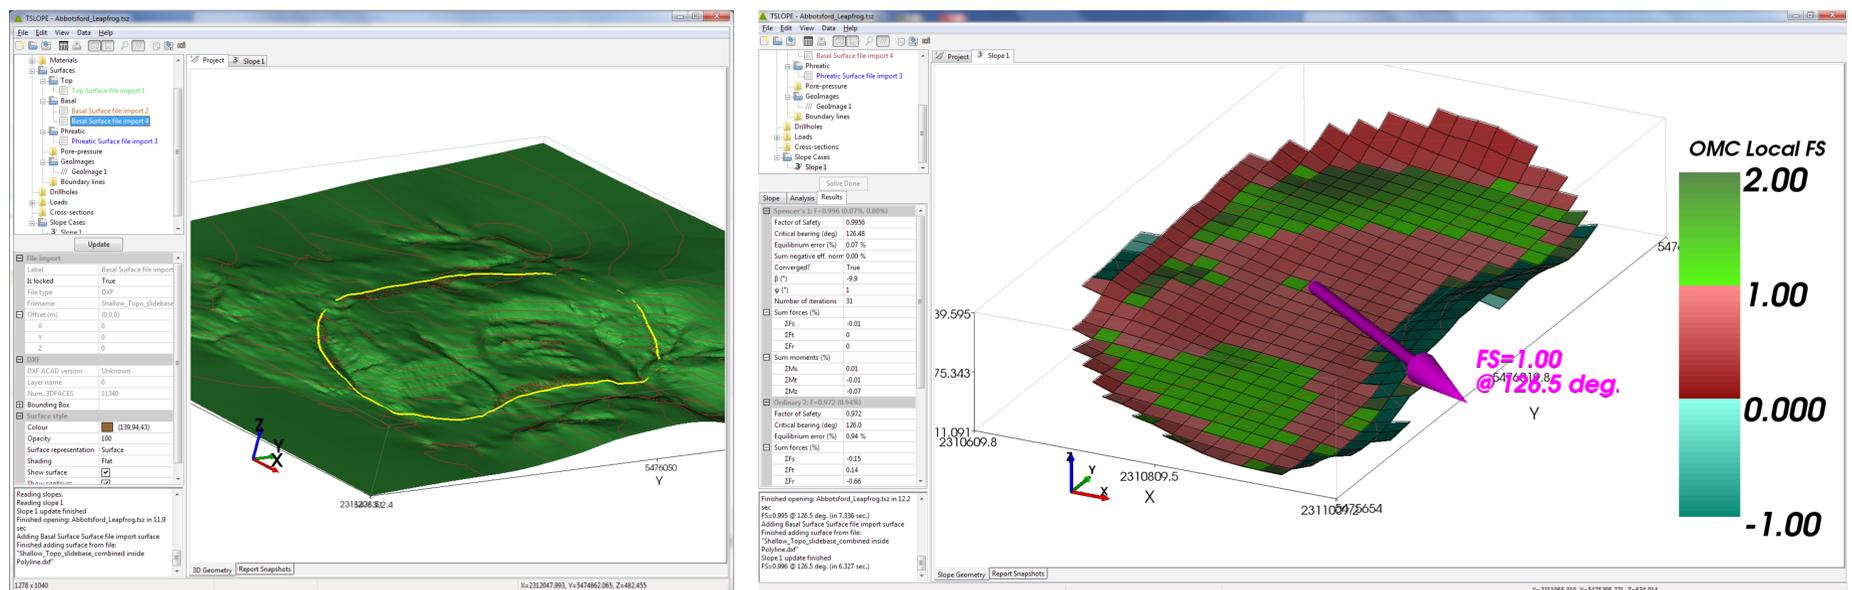
The modelled topographic, failure, and piezometric surfaces were exported to TSLOPE in dxf format. These are the key surfaces to define the geometry of the slope analysis problem. Appropriate strengths were assigned to the failure surface, and 2D analyses carried out to replicate analyses carried out for the Commission of Inquiry. However there was one analysis that has only been able to be carried out recently; that is a 3D analysis from TSLOPE.
